DEPARTMENT OF NATURAL RESOURCES  
DIVISION OF OIL, GAS AND MINING

RE: Site Inspection, Hub Research and Development Company, Bret Clark Mine, S/015/043, Emery County, Utah

Date of Inspection: June 7, 2002  
Time of Inspection: 10:00 a.m. to 12:45 p.m.  
Conditions: Clear, 80's  
Participants: Val Payne, Emery County Public Lands Council; Bret Clark, Operator; Dean Nyffeler and Tom Rasmussen, BLM; Paul Baker, DOGM

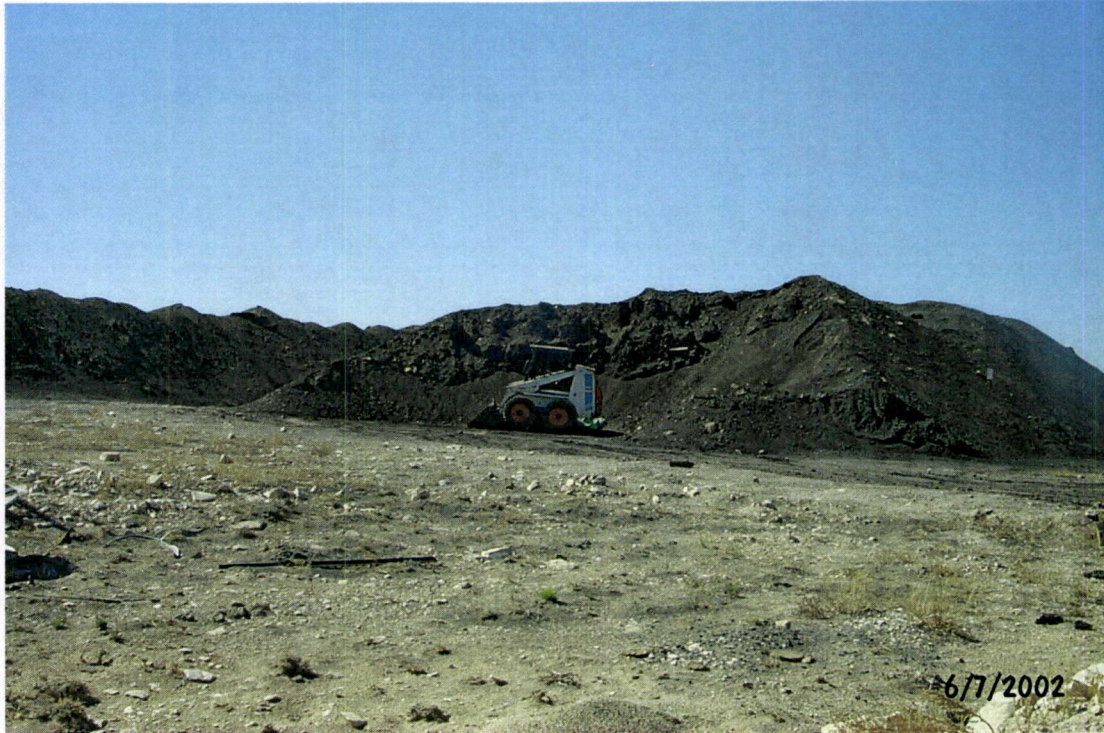
The site has three levels. Items and facilities on top of the plateau include a product stockpile (Photo 1), a log cabin office building, a shack, a trailer, a Sears delivery truck, an outhouse, and various other equipment and scrap (Photo 2). The second level is mainly a road, and the portals are on the lower level.

Photo 1. Product stockpile.

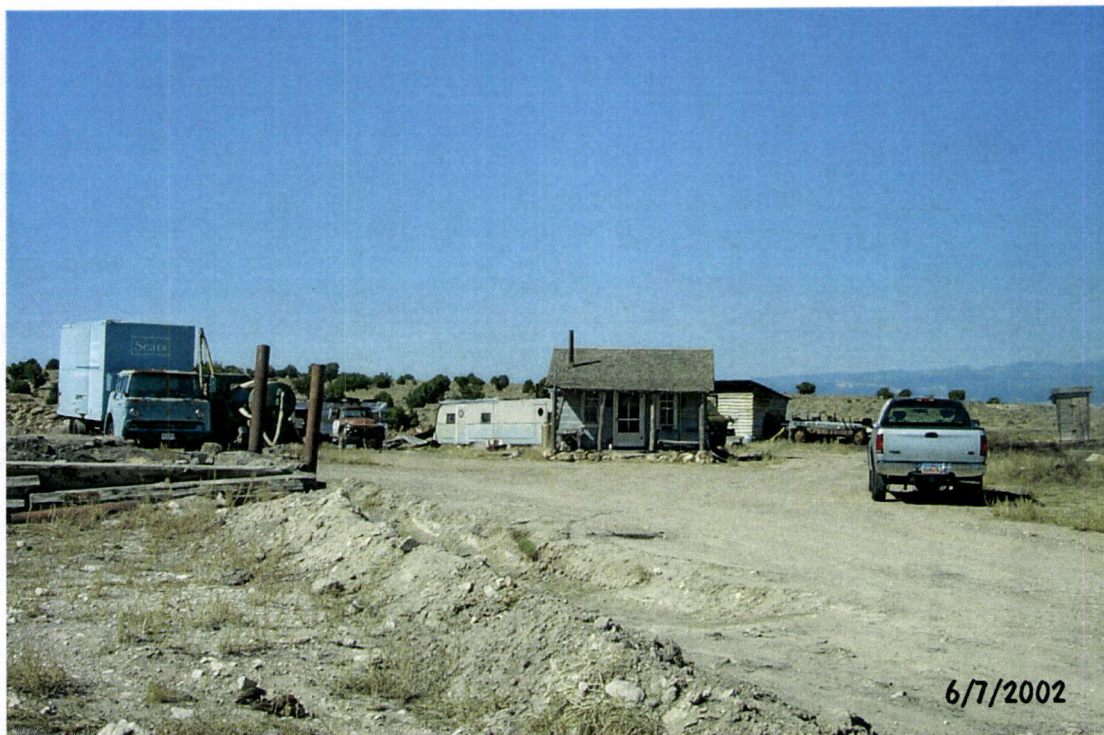
Near the trailer, cabin, and shack, there is a pile of what I consider to be junk and scrap, although Mr. Clark indicated some of the items are still usable. These items are basically consolidated in one place, but anything the operator does not need should be taken away. There are several tires and other debris in the small drainage at the bottom of the outslope. There is some other trash scattered throughout the site, but, for the most part, it is not a serious problem. Nevertheless, this trash should be cleaned up.

Photo 2. Cabin (center), trailer, shack (behind and to right of cabin), and other equipment.

The trash and scrap should be hauled away, including the debris in the drainage below the portals. Anything that will still be needed for the operation needs to be stored neatly.

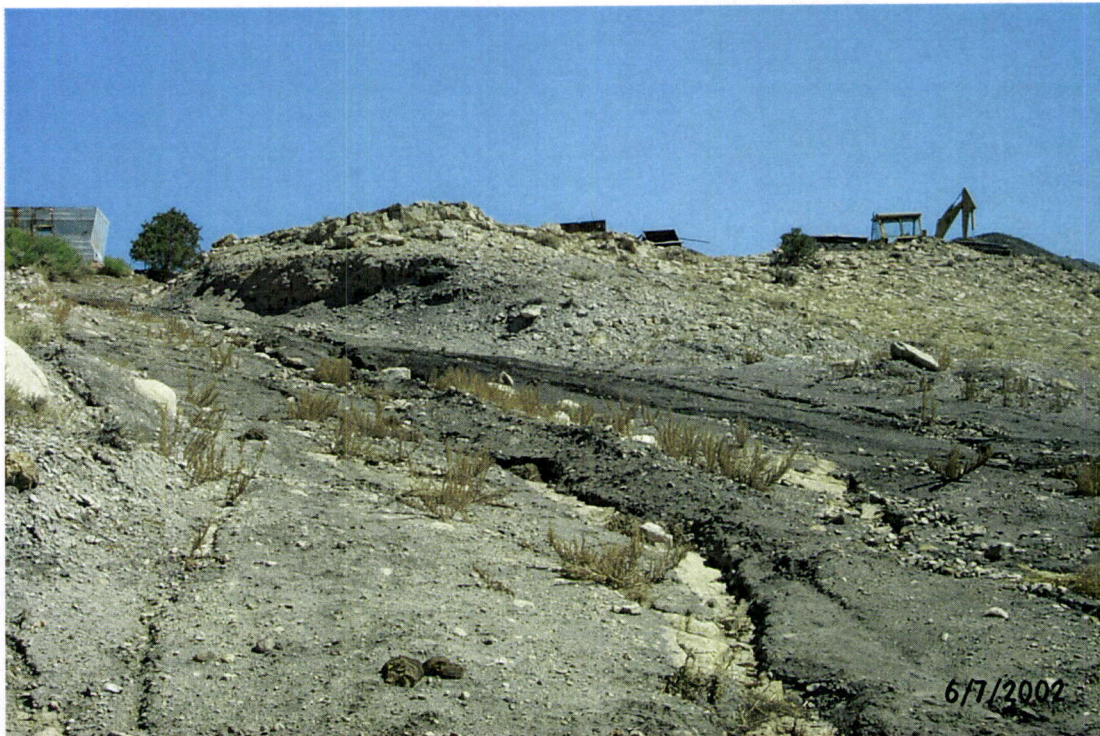
There is a road leading from the south side of the top of the plateau down to the second and lower levels. It appears that water from the upper level of the facility gathers and goes down this road then continues down the outslope of the pad (Photos 3 and 4). There are several rills coming down the road.

Photo 3. Road leading to the lower level. Note the erosion from runoff coming from the upper pad.

The operator should build a berm or a similar containment device to keep runoff from the top of the plateau from going down the road on the south. In addition, Mr. Clark said the upper portion of this road is too steep and will no longer be used for the mining operations, so it should be reclaimed.

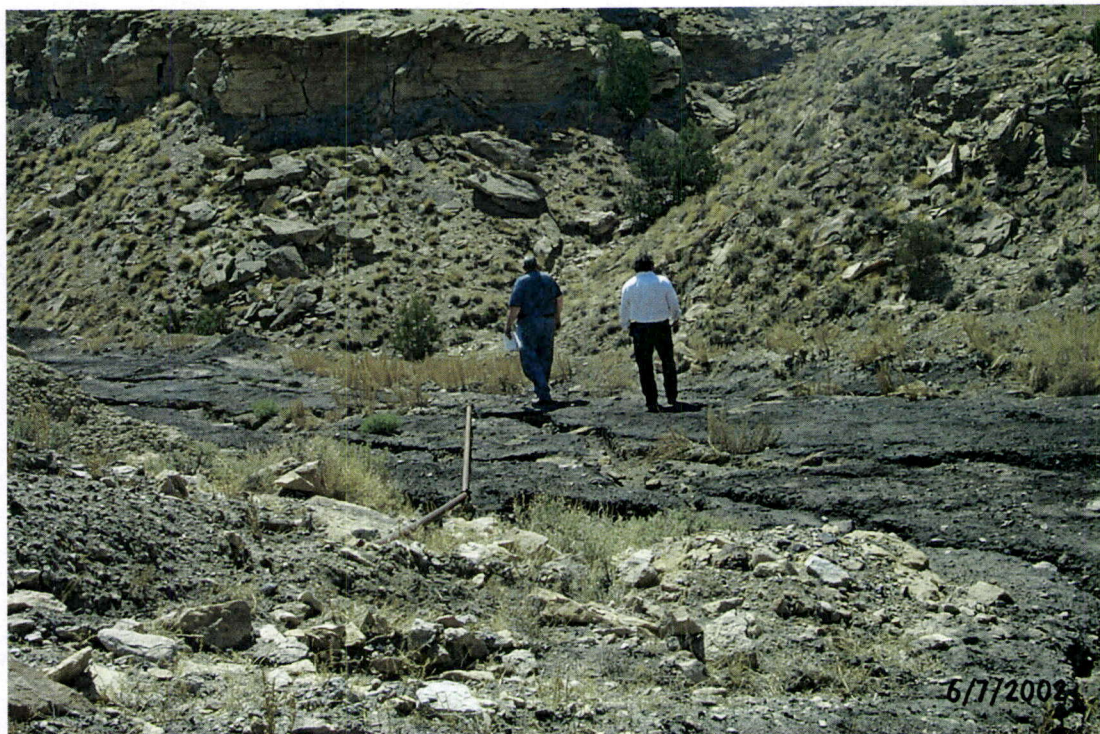
Photo 4. Another view of the road leading to the lower level.

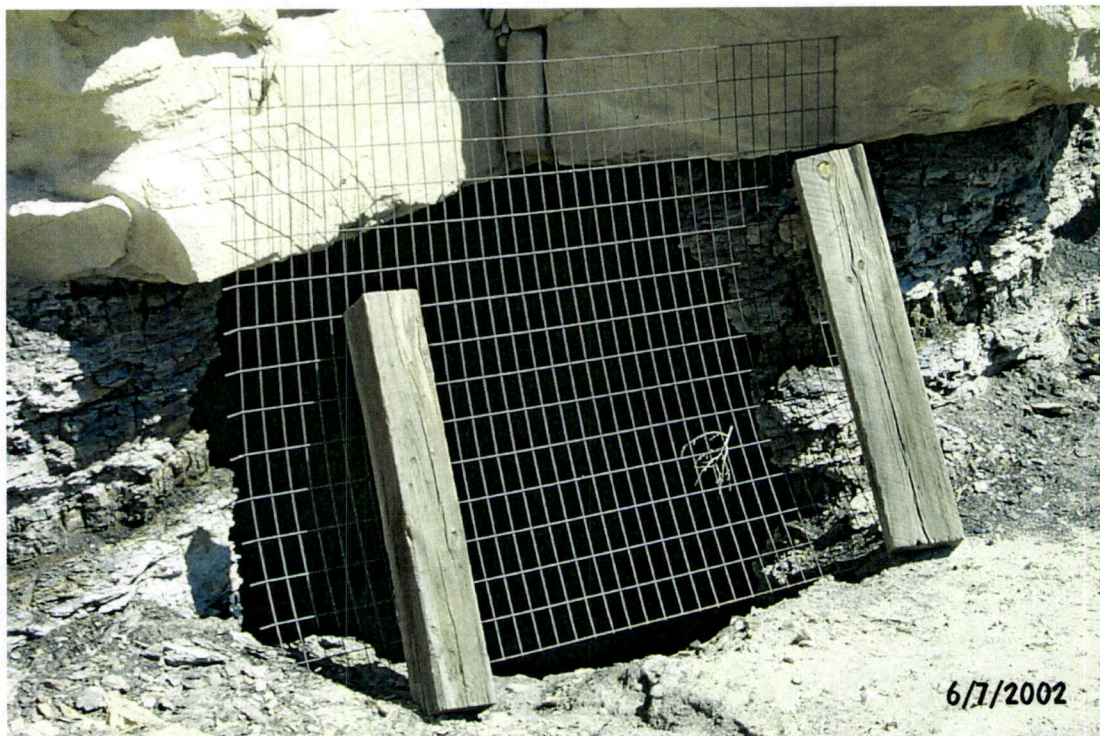
Three portals are on the lower level. One of these (Photo 5) only has fencing material and cribbing to block the way. One of the other portals is partly open so that it would be possible to gain entry. (Photo 6).

Photo 5. Fencing and timbers in front of one of the portals.

The operator needs to secure the portals. This is critical and needs to be done as soon as possible. In addition, there should be signs alerting the public to any hazardous conditions.

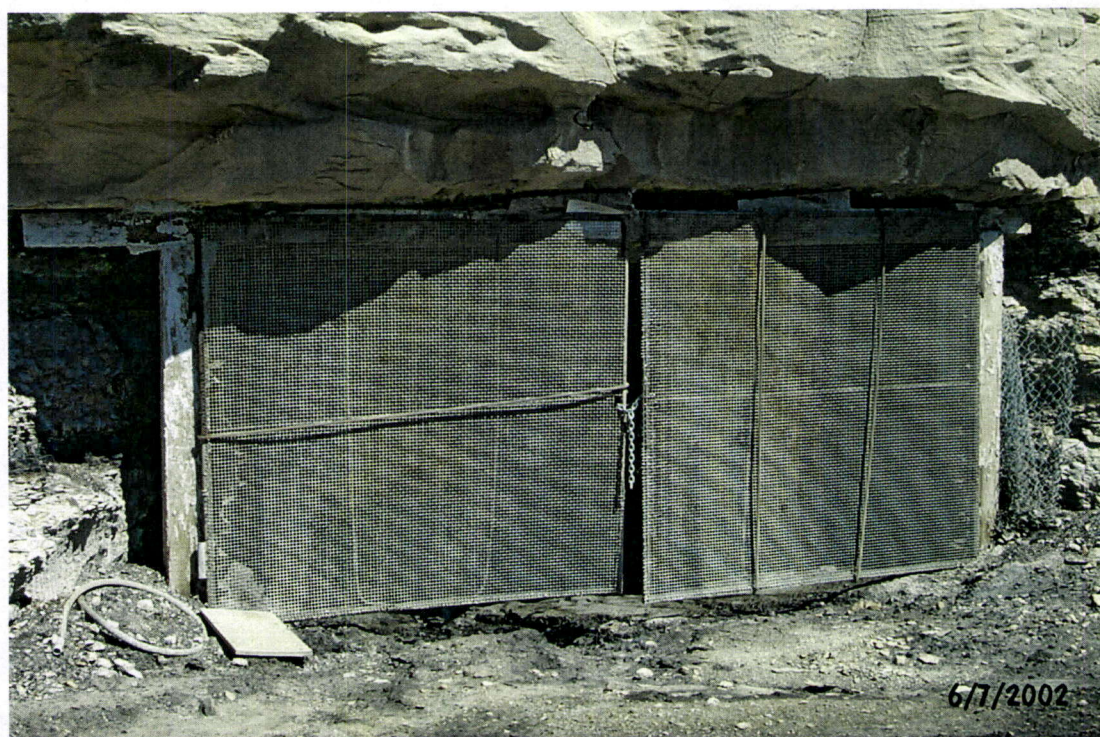
Photo 6. Another portal. It would be possible to gain entry from the side of the gate.

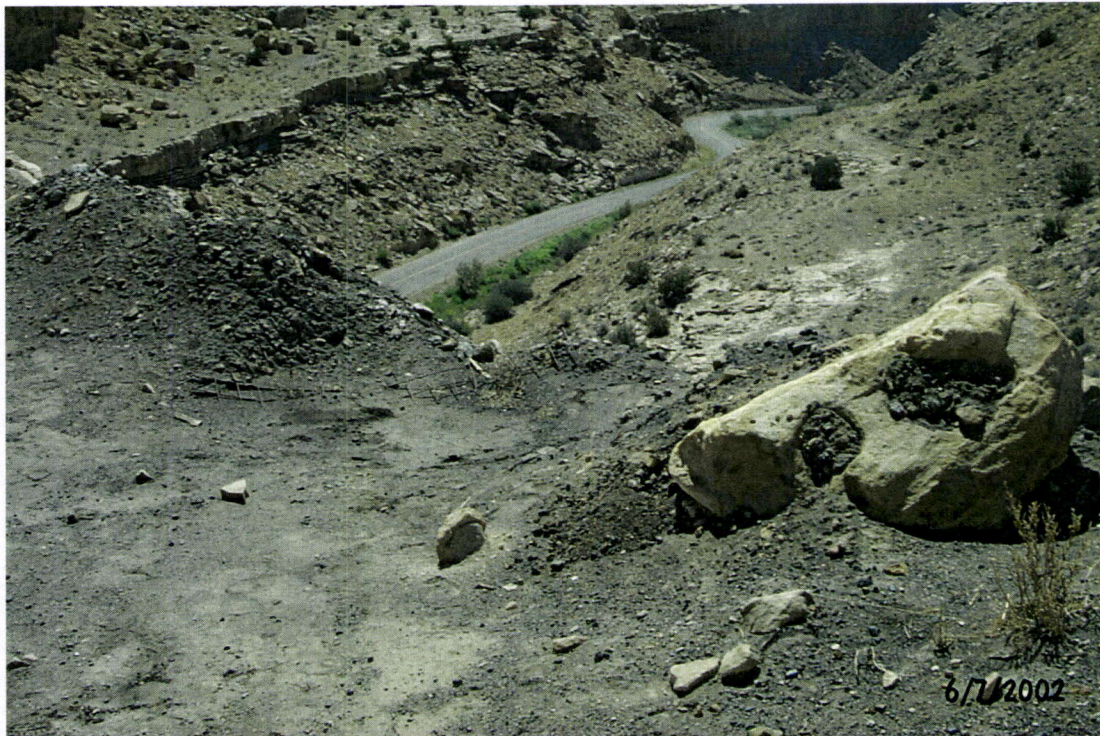
There is a berm at the edge of the pad on the lower level, but this berm is breached in front of most or all of the portals making it possible for water to go down the outslope (Photos 7 and 8). It would be difficult to control runoff resulting from precipitation falling directly on the outslopes, but it would be possible to limit the amount of runoff and sediment coming onto these slopes from the pad. Mr. Clark indicated he thought there had been culverts in these areas that would have taken the runoff down the slope without causing erosion, but we were unable to find these culverts.

Photo 7. A breach in the berm on the edge of the pad.

There needs to be some method of keeping runoff from the portals area from going directly down the outslope of this pad. If, as the operator indicated, there are culverts in these areas, this would probably be an acceptable alternative. Other possibilities would be to *properly* install silt fences or straw bales or to build a berm that would keep all the runoff on the pad. I prefer the silt fence alternative with a slotted spillway. (Mr. Payne explained this concept to Mr. Clark, but the Division would be happy to provide drawing of this type of installation.)

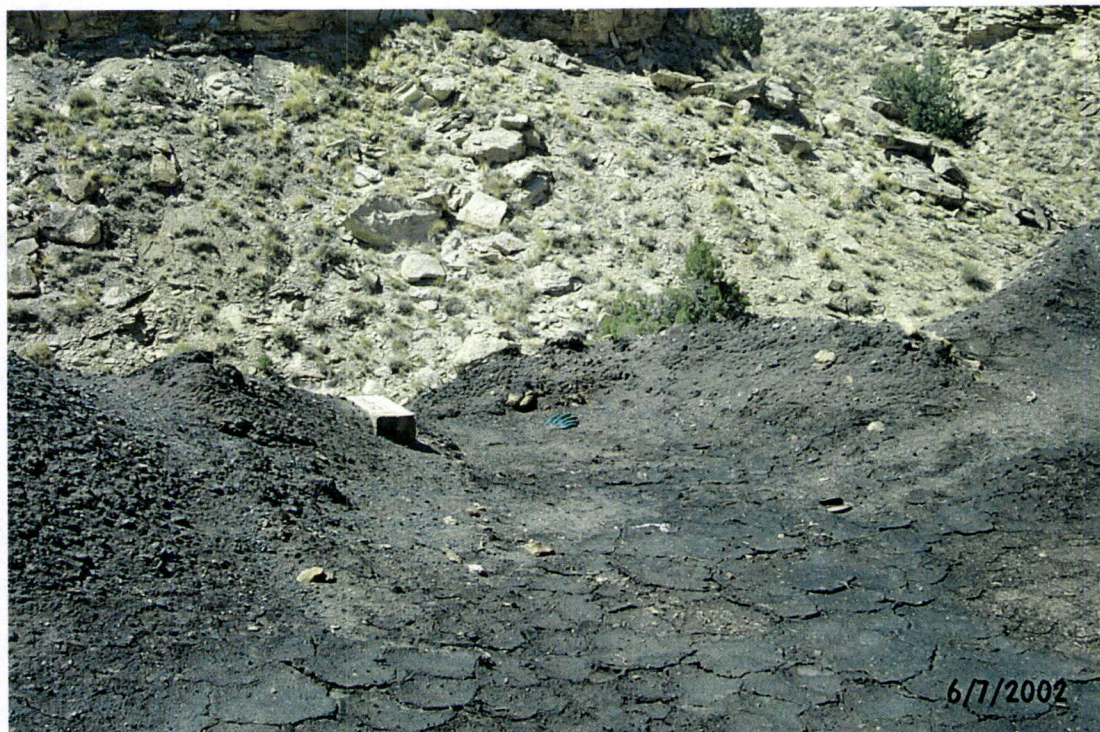
Photo 8. Another breach in the berm where runoff can go down the outslope.
